# **Hunters Point Naval Shipyard Asphalt Waste Disposal at Keller Canyon**

**Hunters Point Shipyard**

**April 2, 2015**

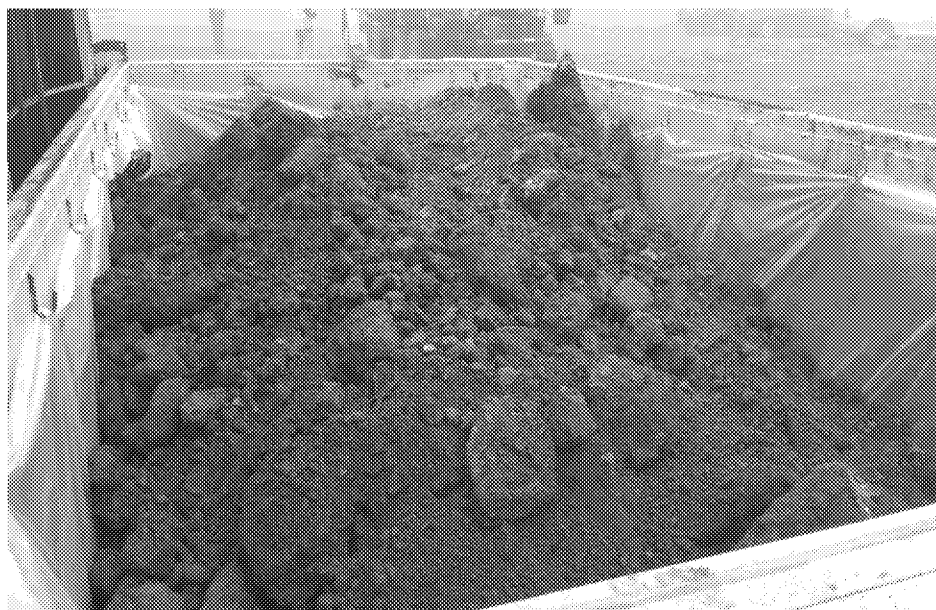
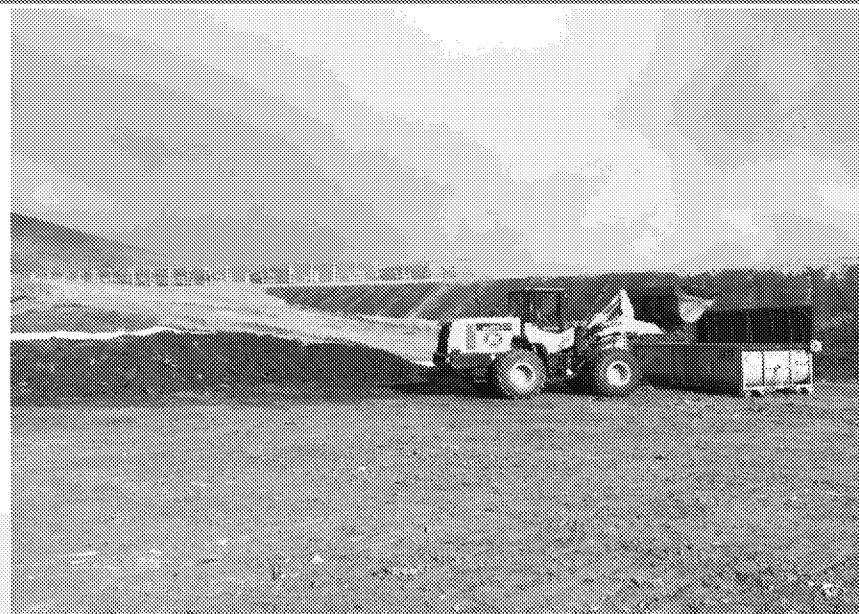
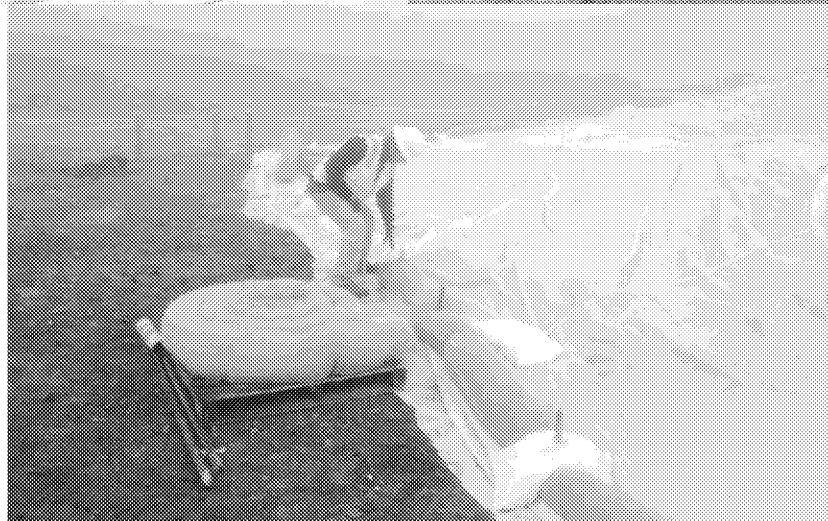
# Keller Canyon Corrective Actions

**February 19-23, 2015:** Navy representatives, Navy contractors, and CDPH-RHB coordinated to safely retrieve the material from the landfill and return it to HPNS for proper screening. Radiological monitoring was conducted during all loading activities.

- The Navy contractor made same day notification to the landfill and isolated the material through the placement of fencing, signage, and other BMPs around the material.
- Navy put an immediate stop to all loading, hauling, and disposal of material from within RCAs an impacted areas across HPNS. (Note: This stop work is still in affect until all corrective actions are implemented).
- Navy mandated that all trucks hauling the material be returned to HPNS for radiological screening and clearance.
- Navy directed basewide T&D contractor to recover and return material to HPNS for proper screening.
- Navy assembled an internal team to determine a root-cause. On February 25, 2015 the Navy team conducted a site reconnaissance and spoke with key personnel involved in the incident.

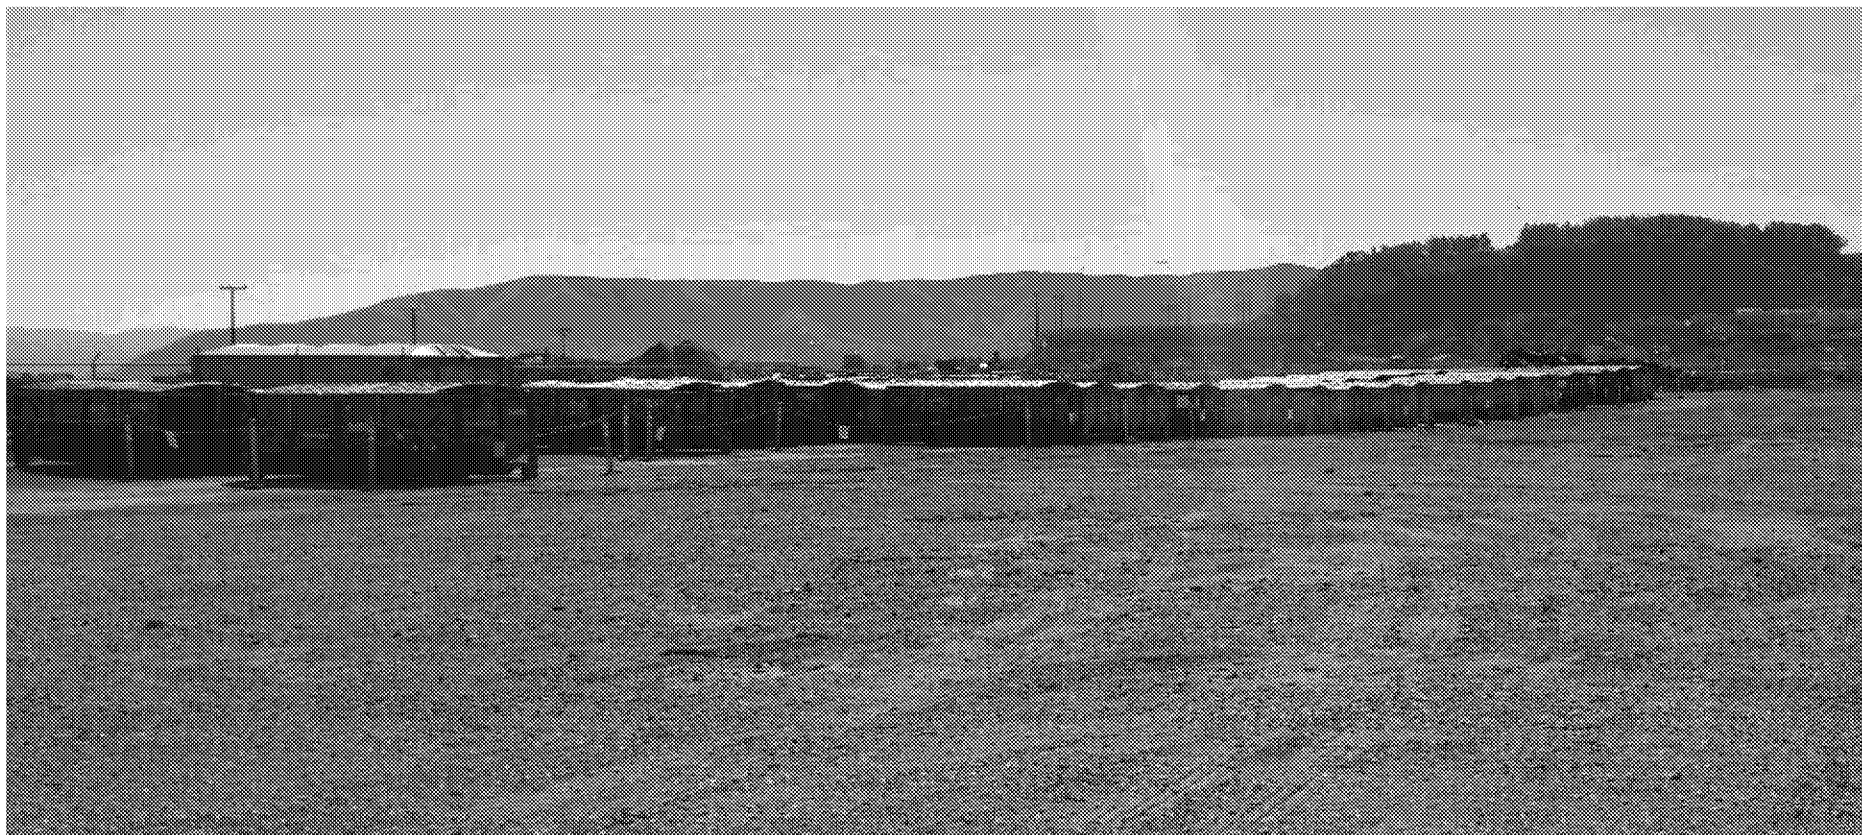
## Picture of Bins Returned to HPNS

**February 24 - March 4, 2015:** Asphalt was transported back to HPNS in sealed bins. A total of 39 bins were returned to HPNS.

**March 20, 2015:** All bins had been emptied and pressure washed. Began process of surveying and swiping bins for free-release.

**As of April 2, 2015:** 13 bins (not the soil within) have been released by RASO.
